Amendment 39-17113; AD 2012-13-11]

Airworthiness Directives; Eurocopter Deutschland GmbH Helicopters

2012-13-11 EUROCOPTER DEUTSCHLAND GMBH HELICOPTERS:

This AD defines the unsafe condition as an improperly swaged spherical bearing on the pitch link, which could result in loss of tail rotor control and subsequent loss of control of the helicopter.

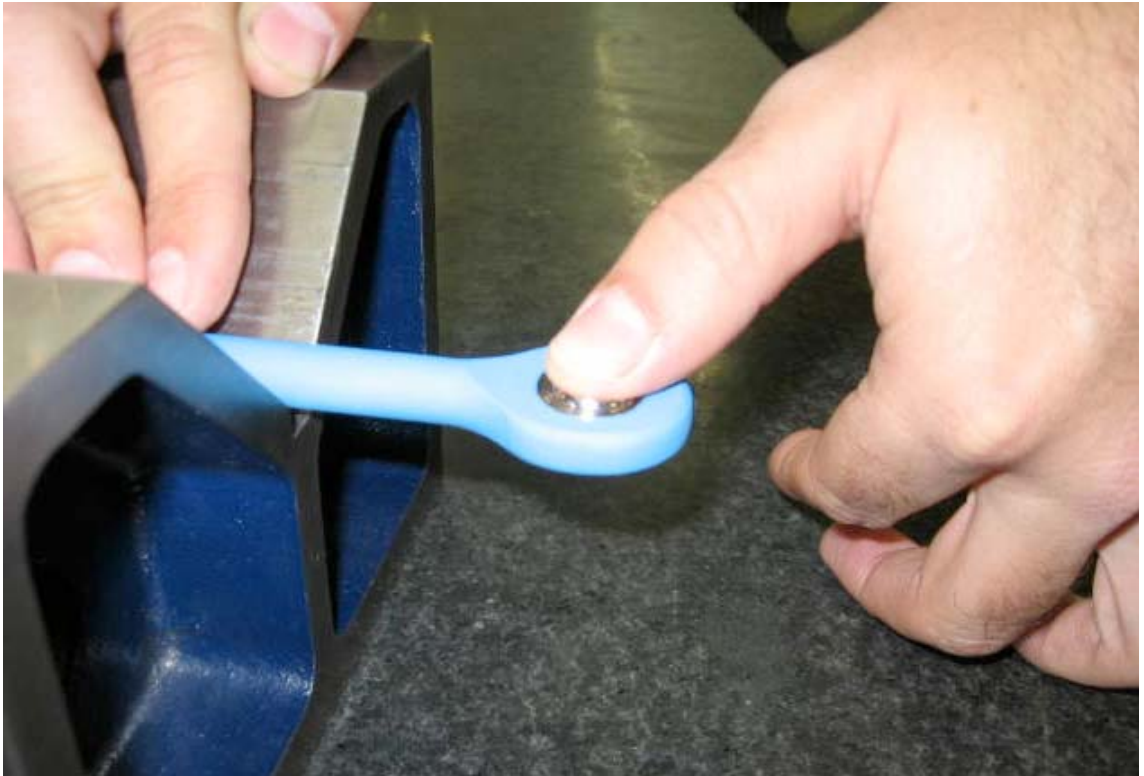
(3) Apply axial hand pressure to the faces of both spherical bearings as shown in Figure 1 to Paragraph (e) of this AD.

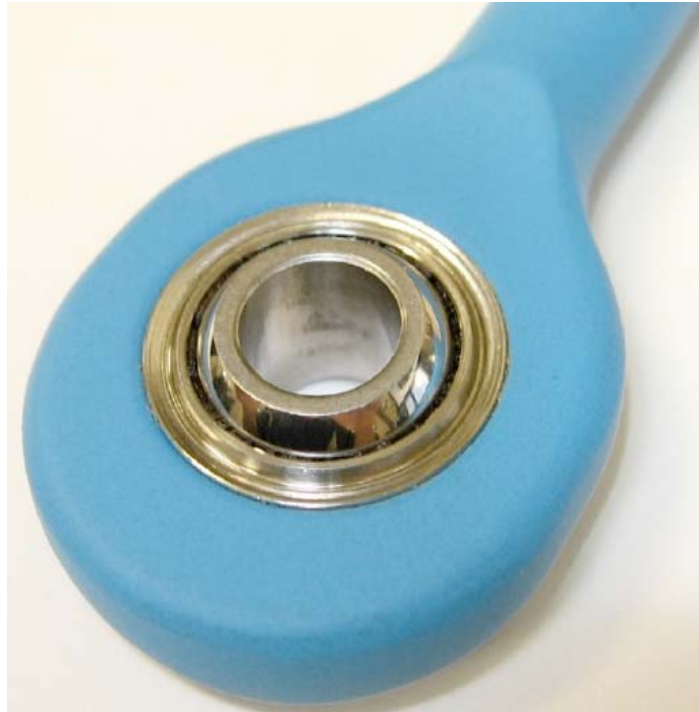
(4) Using an 8X or higher power magnifying glass, inspect the boundaries between the bearing and the bearing bore chamfer surface. Determine that the bearings have been completely swaged and there is no gap between the edge of the bearing and the chamfer as shown in Figure 2 to Paragraph (e) of this AD.

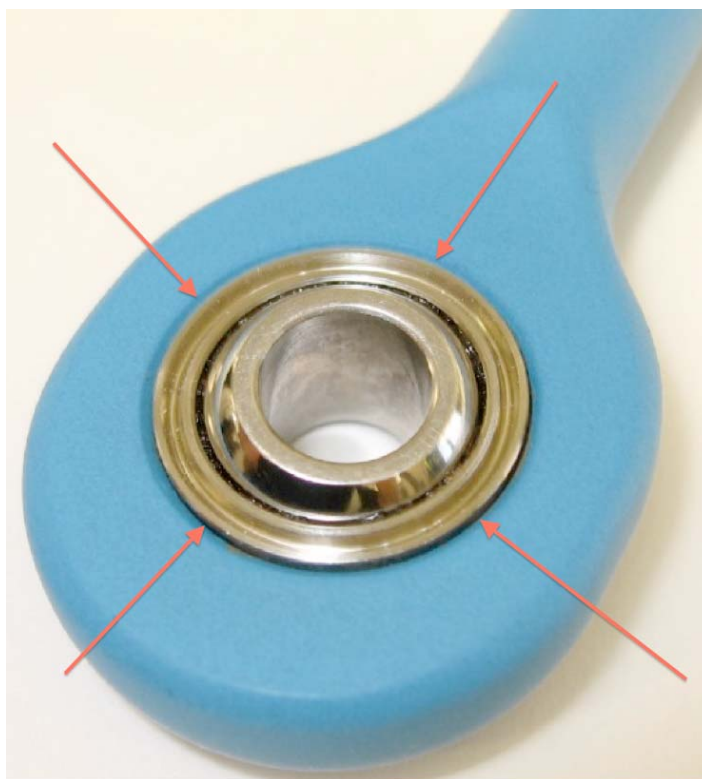
(5) If a bearing is not completely swaged or there is a gap between the edge of the bearing and the chamfer, as shown in Figure 3 to Paragraph (e) of this AD, replace the pitch link with an airworthy pitch link.
